# Manhole Inspection Summary

Manhole # S33M1\_009MH

Insp Date: **3/24/08 1:08 PM**

**Location** Address: **201 Seamon Ave.**

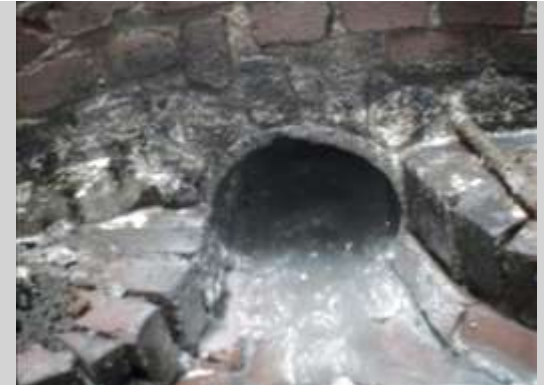
10 in. Circular Gravity Sewer  
Pipe Out @ 12 O'Clock

Pipe Height: **10.8** (in.) Rod and Bar (Angled)  
Pipe Material: **Clay** ☐ Pipe Lined  
Invert Depth: **13.08** (ft.) Flow Characteristics: **Fast**  
Deposits: ☒ None ☐ Mud ☐ Sludge ☐ Debris ☐ Grease  
Silt Depth: (in.) Deposits Extent:  
Infiltration: **None** Pipe Seal Cond: **Sound**

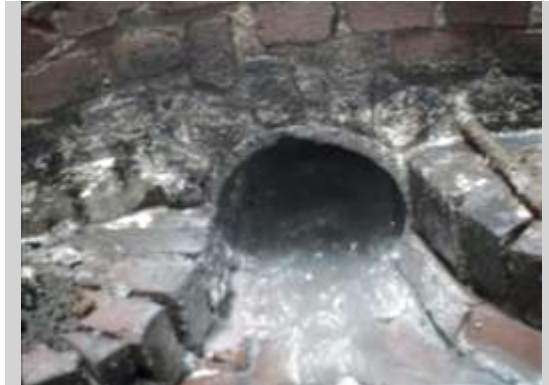
12 O'Clock Outflow  
Pipe Out @ 12 O'Clock

Pipe Height: **8.4** (in.) Rod and Bar (Angled)  
Pipe Material: **Clay** ☐ Pipe Lined  
Invert Depth: **12.79** (ft.) Flow Characteristics: **Fast**  
Deposits: ☒ None ☐ Mud ☐ Sludge ☐ Debris ☐ Grease  
Silt Depth: (in.) Deposits Extent:  
Infiltration: **None** Pipe Seal Cond: **Cracked**
